## 29. Ponteland Bridge

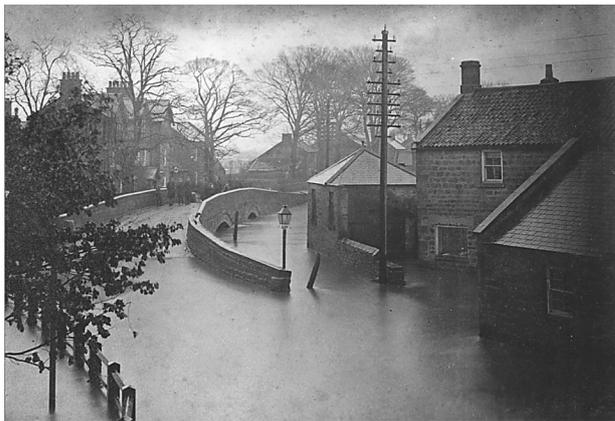
There was also the recurrent problem of flooding, which was exacerbated by the restriction on the water flow due to the narrowness of the two arches. The adjacent photograph, in which water can be seen virtually at the top of the arches, dates from the flood of 1903. It was one of many photographs taken by the Reverend David Langton

The photograph was evidently taken from the first floor of the Coates Institute, and it is possible to see a significant gap between the right-hand wall of the bridge abutment and the small building behind the telegraph pole. It is thought that this gap may have led to an earlier ford across the river. The small building with the pyramidal roof is nowadays often referred to as The “Toll House” but in fact it was the adjacent butcher’s slaughter house. [1] The Toll

House was actually the single-storey building on the extreme right of the picture, but it was demolished three years after the 1903 flood to be replaced by the Lambton's Bank building, which was later taken over by Lloyds Bank. This, in its turn, was demolished in the late 1950s and a new Lloyds Bank built on its present site a little to the south. These measures virtually doubled the width of carriageway at this point, and the new parapet wall became virtually continuous with the north wall of the old slaughterhouse.

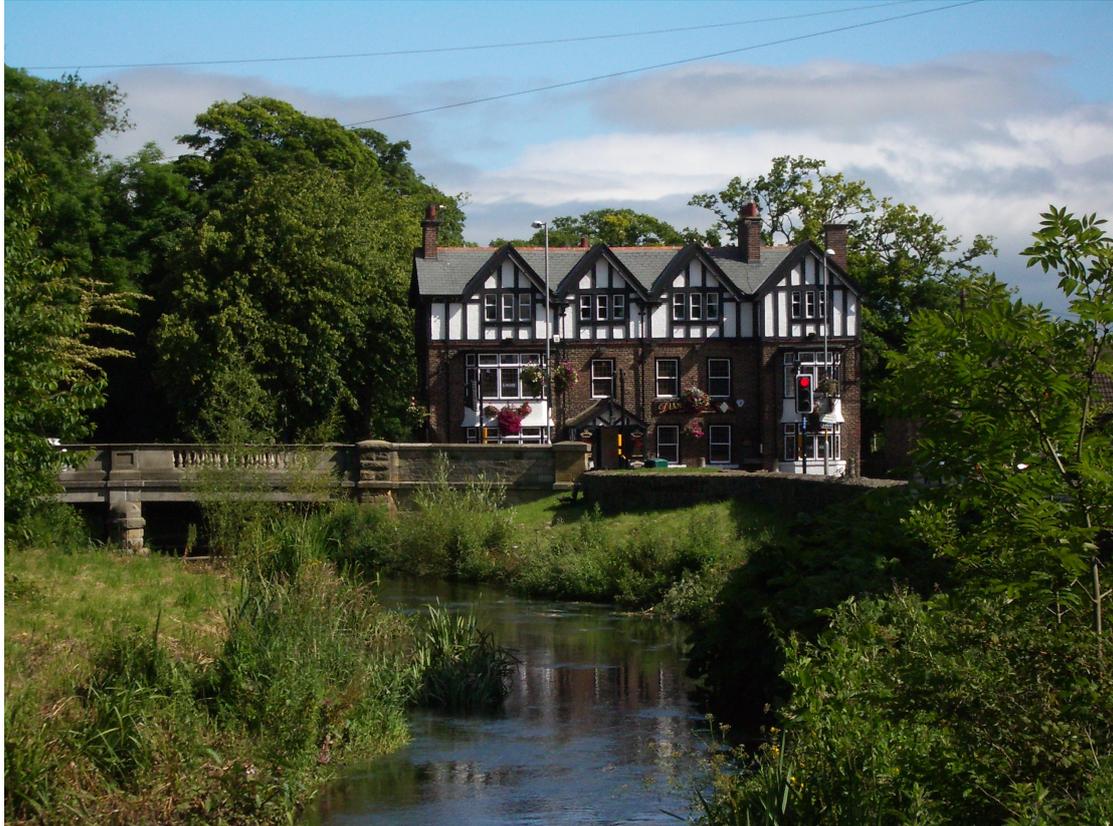
The 1925 bridge has two narrow piers between which and the abutments the carriageway is supported on horizontal beams. This design provides a much increased passage through which flood waters may flow, so reducing the water level upstream of the bridge (but not entirely eliminating the flooding problem *per se*). The parapet wall contains turned stone columns on both sides of the bridge, so giving a sense of lightness to the whole structure.
